# Fenestration Testing Laboratory, Inc.

Report #: T19-089

4000 - PVC OUTSWING SIDE-HINGED DOOR

NAFS - North American Fenestration Standard/specification for windows, doors, and skylights  
AAMA/WDMA/CSA 101/I.S.2/A440-17

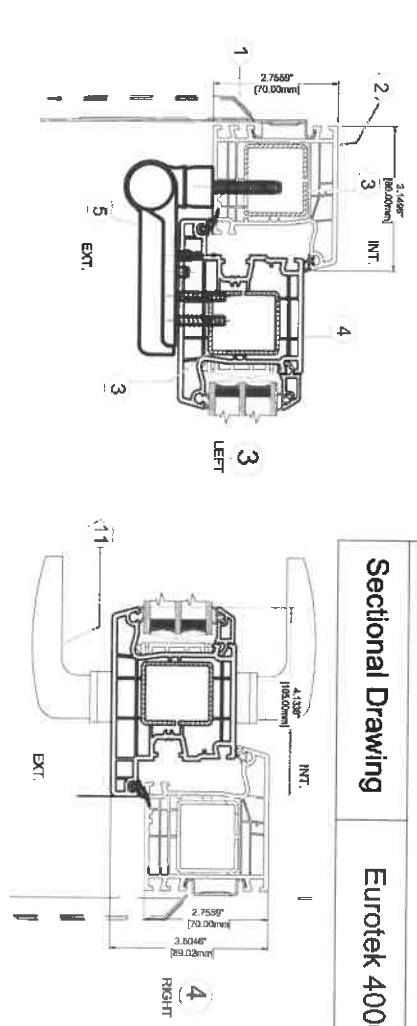
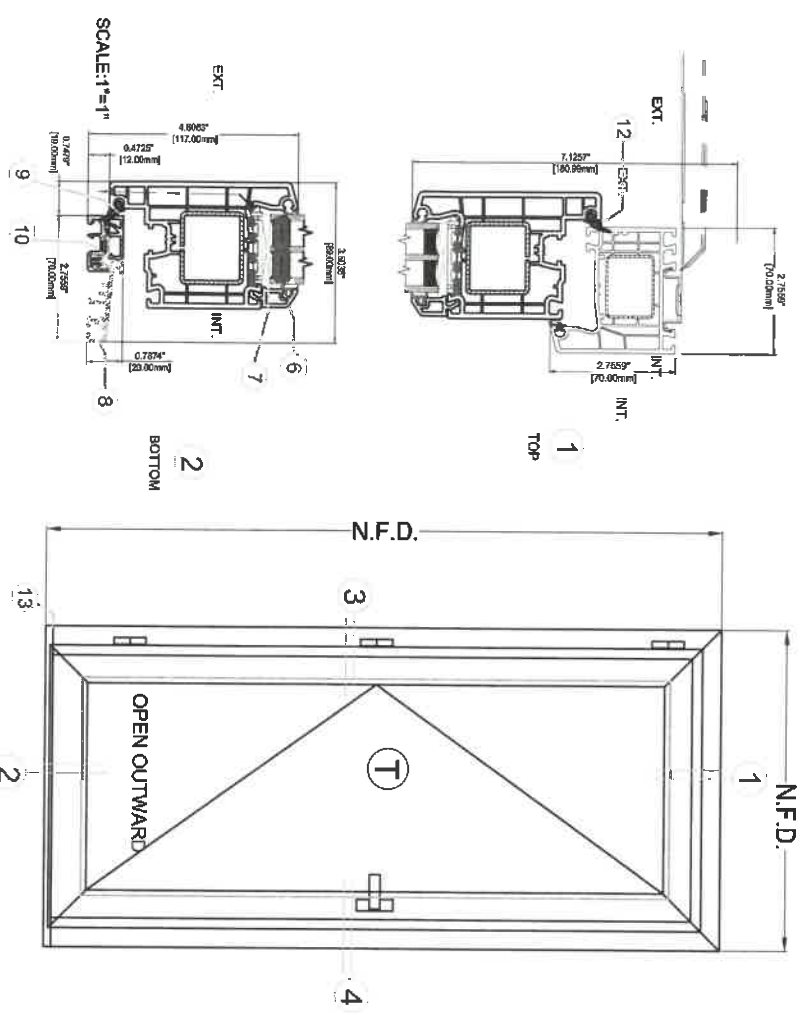
**BOM**

INDEX	PART NUMBER	DESCRIPTION	QTY	VENDOR	MATERIAL
1	6203410	Wall Anchor	8	ALUPLAST	PVC
2	1489303	Main Frame 80mm x 70mm	3	ALUPLAST	PVC
3	229115	Steel Reinforcement	7	ALUPLAST	Galvanized Steel
4	1489331	Outswing Sash - 105mm x 70mm	4	ALUPLAST	PVC
5	K470G0000	Dr. Hahn Flap Hinge	3	Dr. Hahn	Aluminium
6	120736	Glazing Bead	4	ALUPLAST	PVC
7	620920	Gilching Blocks	4	GKG	UPVC
8	249800	Threshold 4000 Series	1	ALUPLAST	Anodized Aluminium
9	249850	Threshold 4000 Series	1	ALUPLAST	PVC
10	249850	Threshold 4000 Series	1	ALUPLAST	PVC
11	11882483	Verona Handle	1	Hoppe	Aluminium
12	409932	Special Gasket for high performance	4	ALUPLAST	Rubber
13	048072	Threshold connector for frame	2	ALUPLAST	Plastic

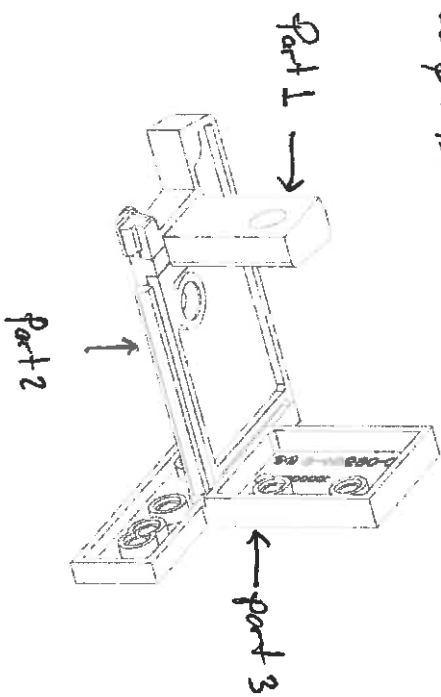
Three parts

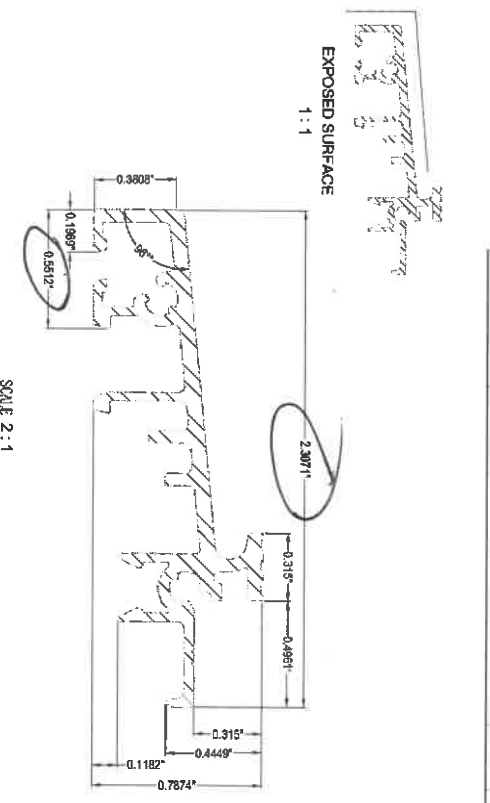
EXPOSED SURFACE  
1 : 1

SCALE 2 : 1
